# BOARD OF COUNTY COMMISSIONERS STUDY SESSION AGENDA

**STUDY AGENDA SUBJECT:**  
2021-2023 Special Bridge Project Planning Discussion

# Culvert

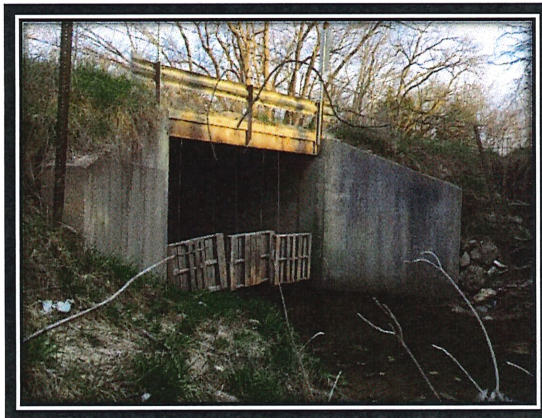
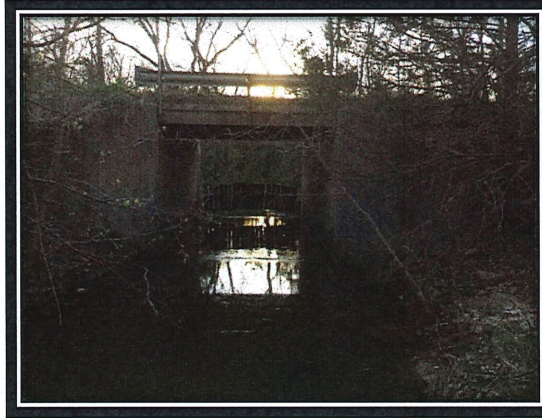
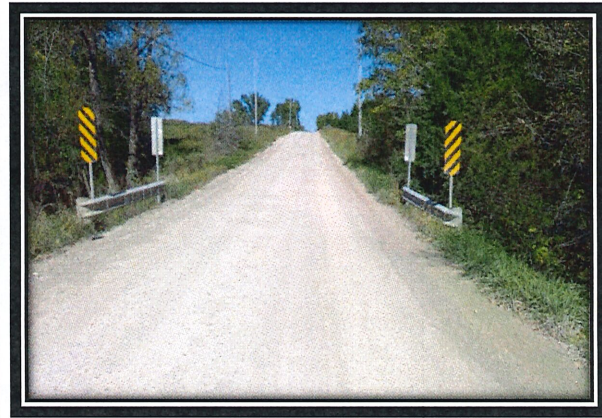
## Culvert #841: Lonestar Road s/o K68 (Steel Stringer)

Structure Span	Structure Width	Deck Condition	Superstructure Condition	Substructure Condition	Culvert/Pipe Condition	Channel Condition
13	24	6	4	7	N/A	7

12" Steel Stringers heavily corroded, I-beam webs corroded out. Infall pooled-no scour, flat channel, pallet panel restriction. WW ends erosion. Outfall drops, no scour, long pool, flat channel. Suggest additional structural evaluation. Beams 2 and 12 failed and beams 1 and 13 are imminent to fail.

Construction will be completed in 2021

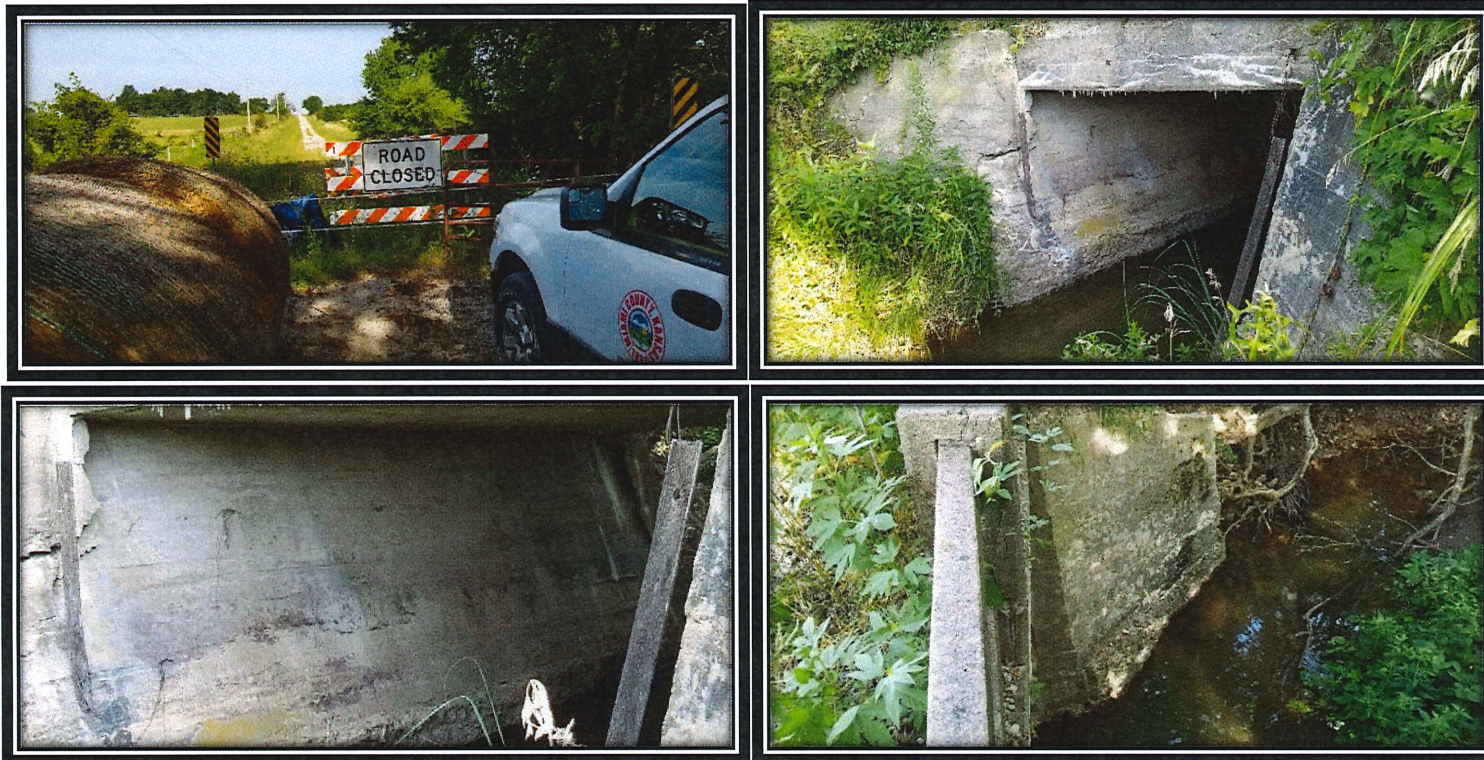
## Culvert #2616: 327<sup>th</sup> Street w/o Switzer (Reinforced Concrete Slab)

Structure Span	Structure Width	Deck Condition	Superstructure Condition	Substructure Condition	Culvert/Pipe Condition	Channel Condition
12.1	20.5	5	3	1	N/A	3

West abutment failed. Scour caused west abutment to collapse tipping out of plain. Loss of load path 100%. Concrete sheared and broken at moment areas. Channel alignment migrating towards west abutment. Vertical banks with heavy erosion.

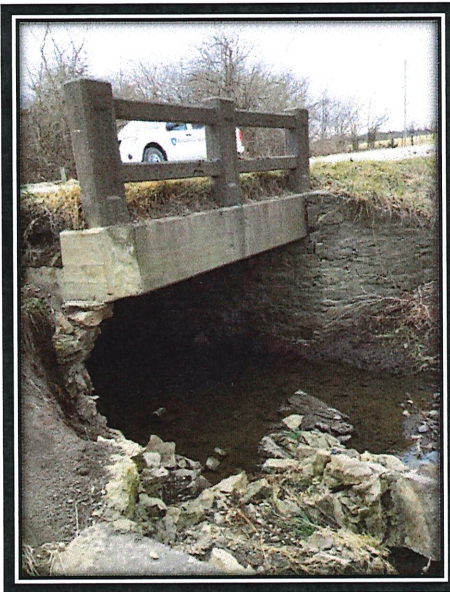
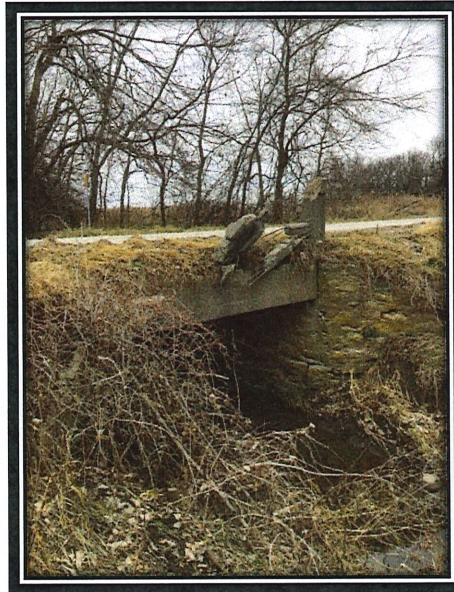
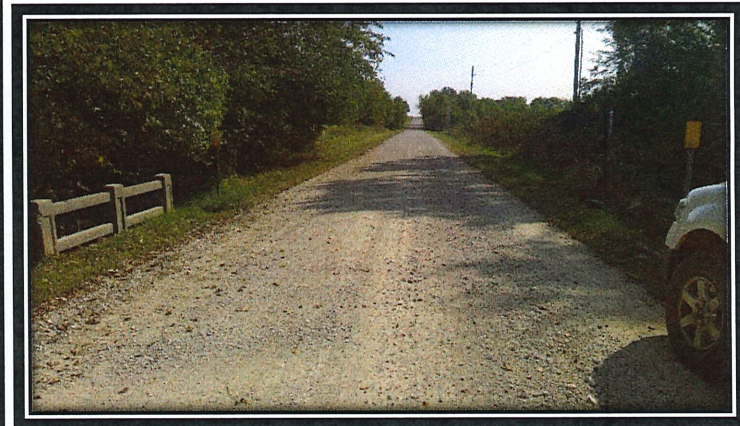
## Culvert #249: 231<sup>st</sup> Street e/o Mission (Concrete Slab)

Structure Span	Structure Width	Deck Condition	Superstructure Condition	Substructure Condition	Culvert/Pipe Condition	Channel Condition
10	24	6	6	3	N/A	6

Northeast masonry wing is collapsed into channel, east masonry abutment has extensive crushing, first layer of stone has failed on east abutment.

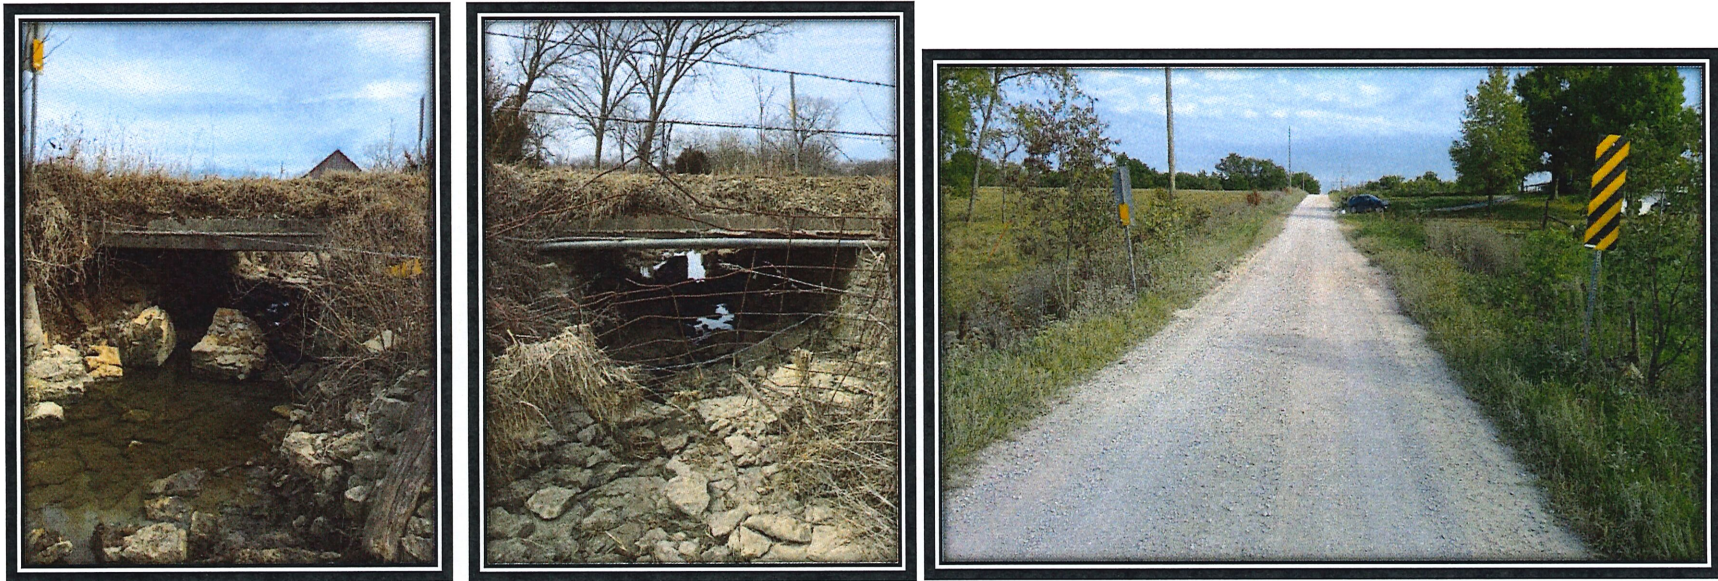
## Culvert #1926: Block Road s/o 351<sup>st</sup> Street (Steel Stringer)

Structure Span	Structure Width	Deck Condition	Superstructure Condition	Substructure Condition	Culvert/Pipe Condition	Channel Condition
10	20	6	6	3	N/A	6

Severe deterioration, abutments are failing.

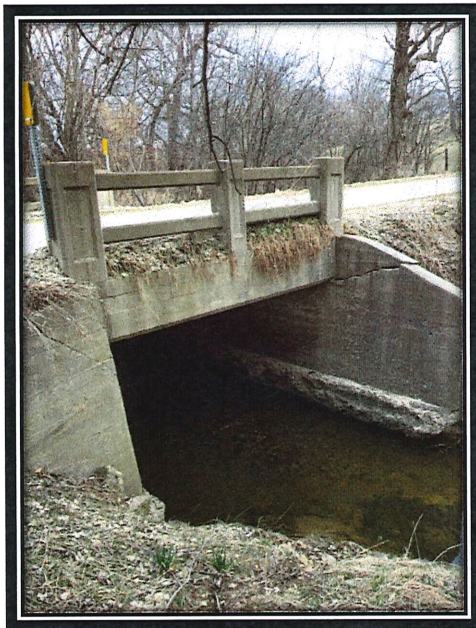
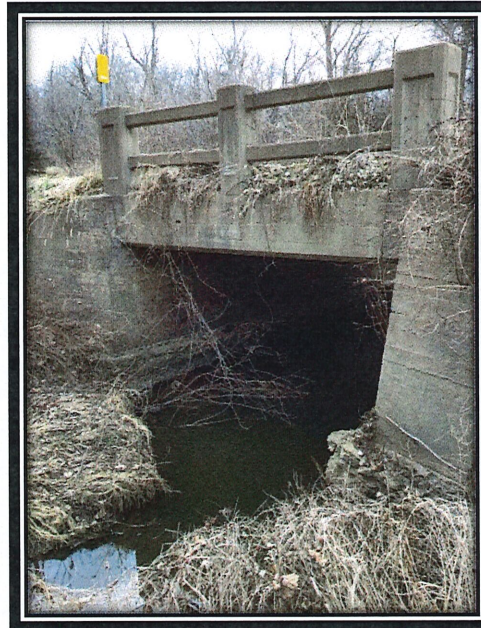
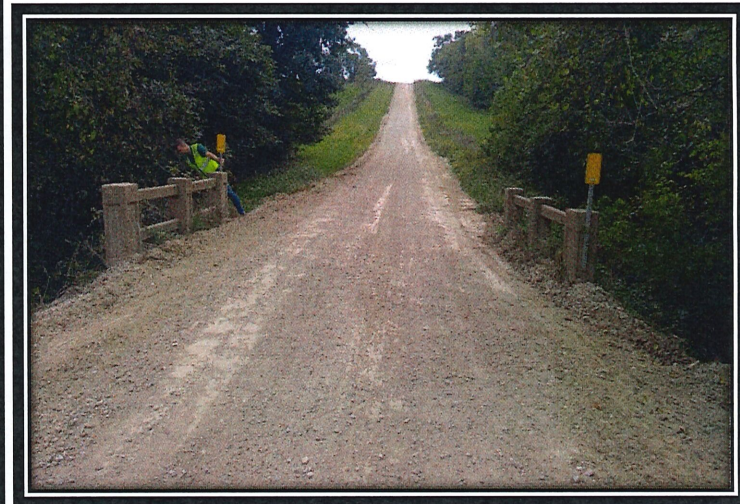
## Culvert #1208: Plum Creek Road n/o 311<sup>th</sup> Street (Concrete Slab)

Structure Span	Structure Width	Deck Condition	Superstructure Condition	Substructure Condition	Culvert/Pipe Condition	Channel Condition
12	18	6	6	3	N/A	3

Deck is separated from the south abutment has pushed 3 inches. Major scour under both abutments and all wings.

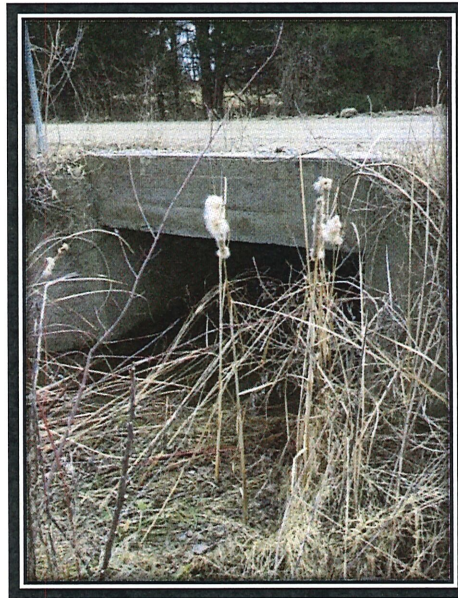
## Culvert #1750: 335<sup>th</sup> Street w/o Switzer (Concrete Slab)

Structure Span	Structure Width	Deck Condition	Superstructure Condition	Substructure Condition	Culvert/Pipe Condition	Channel Condition
13	24	4	3	0	N/A	4

Structure has failed.

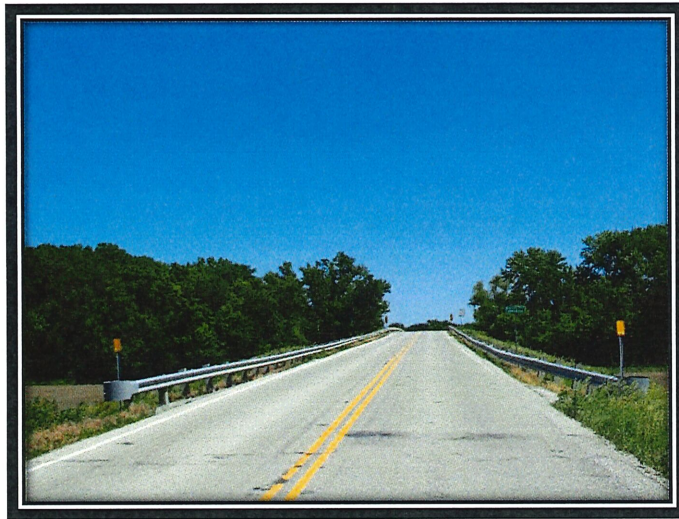
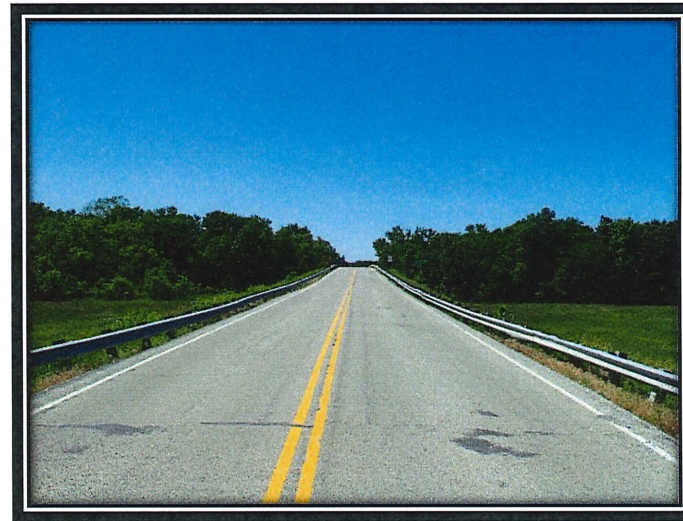
## FAS 270- Hospital Drive 0.33 w Hedge Lane (Guardrail)

Guardrail outdated. Upgrade to crash worthy guardrail.

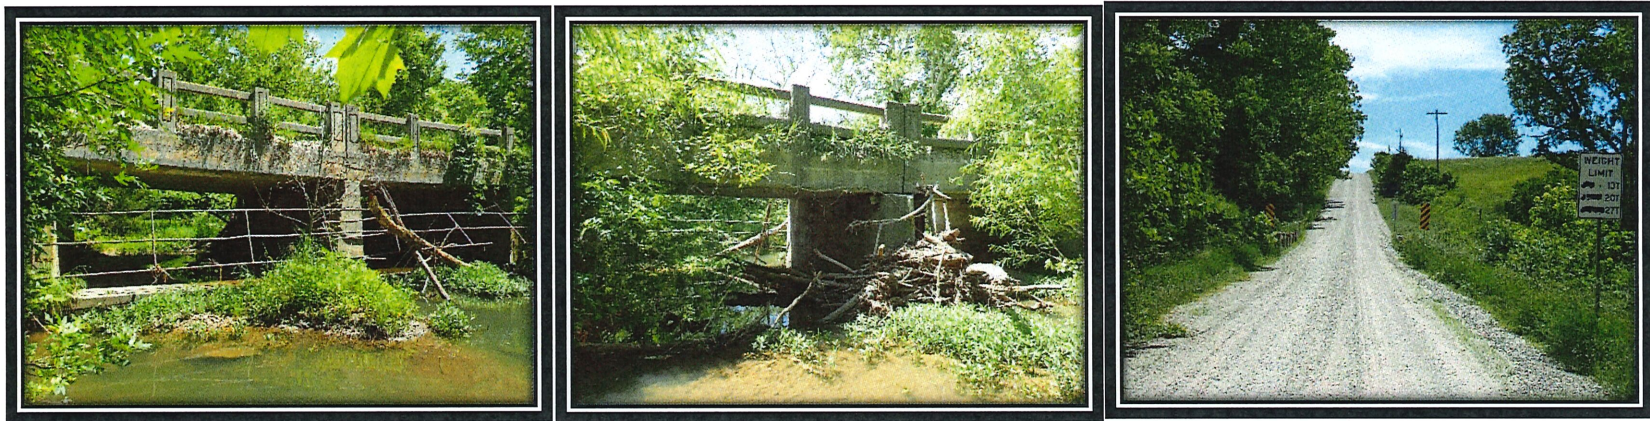
## Bridge 1-F.2-399<sup>th</sup> Street east of Crescent Hill (Reinforced Concrete Slab)

Structure Span	Structure Width	Deck Condition	Superstructure Condition	Substructure Condition	Culvert/Pipe Condition	Channel Condition
16.1	17.7	4	4	5	N/A	5

Deck: Covered by gravel. Superstructure: Several shallow spalls with exposed rebar along soffit at edges of both spans. Substructure: Helper bent in span 1 in generally good condition with light surface rust. Concrete pier has large spalled area at SW corner. Channel: Flow north to south. Debris accumulation at pier. 1' drop at upstream and downstream floor.

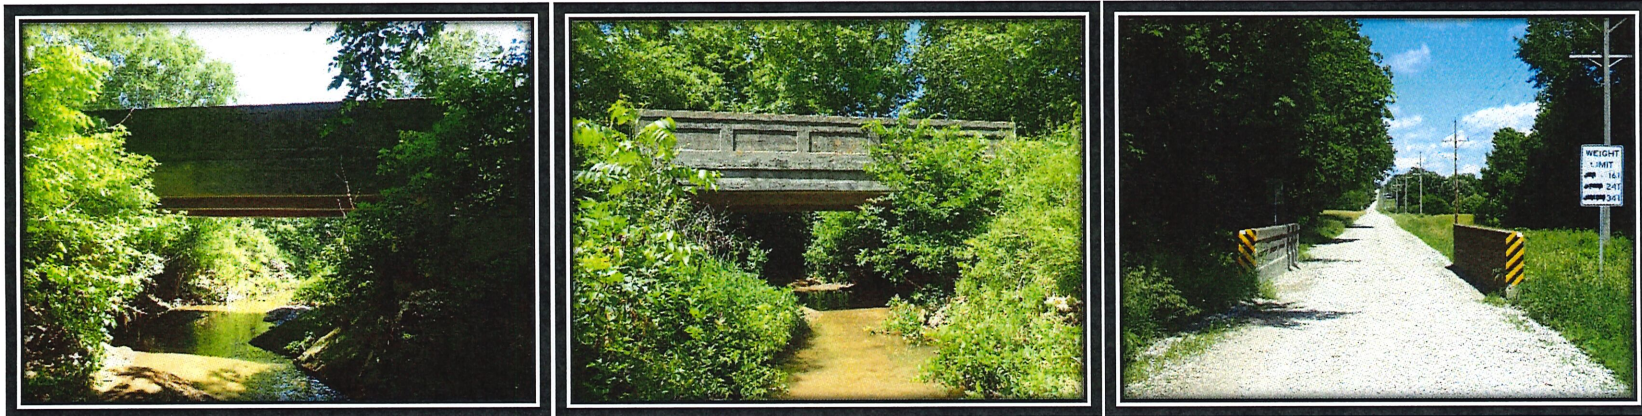
## Bridge 12-C.2- 311<sup>th</sup> Street east of Pressonville Road (Concrete Girder)

Structure Span	Structure Width	Deck Condition	Superstructure Condition	Substructure Condition	Culvert/Pipe Condition	Channel Condition
30.8	16.3	4	4	4	N/A	4

Superstructure: Large spalled area with exposed rusting rebar on top flange between beam 1 & 2. Beam 1 has hairline longitudinal cracking on stem. Substructure: Northwest wing breaking away from west abutment. No wing at SW corner. Channel: Flow north to south. Angle of attack at NW wing. 2'-2.5' of exposed abutment footing at both abutments.

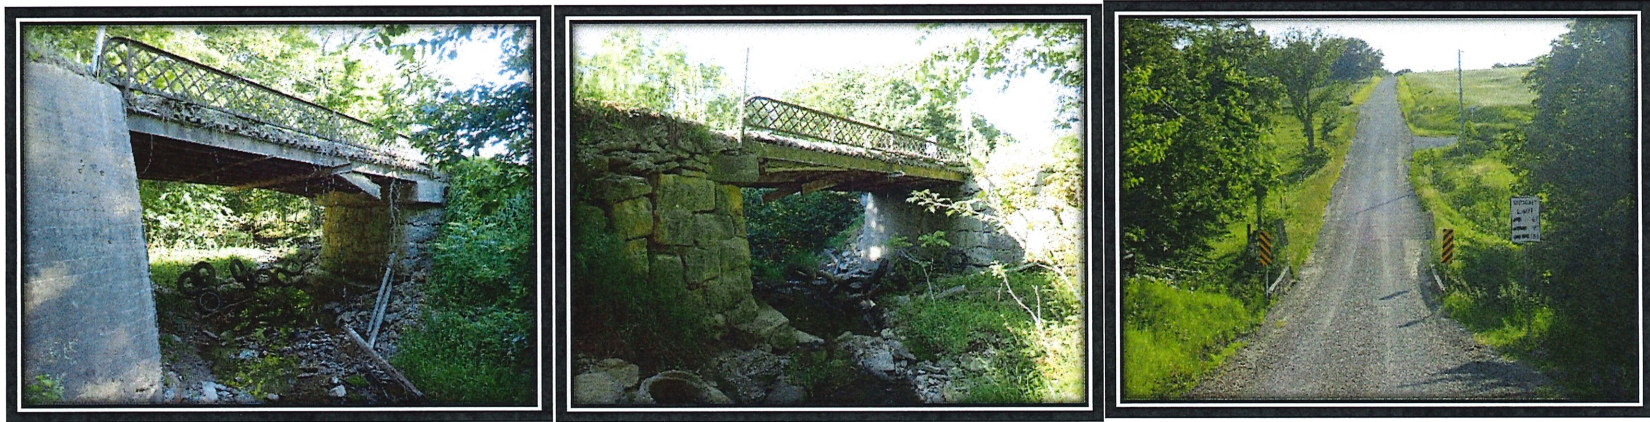
## Bridge 21-D.1-239<sup>th</sup> Street west of Bethel Church Road (Steel Girder)

Structure Span	Structure Width	Deck Condition	Superstructure Condition	Substructure Condition	Culvert/Pipe Condition	Channel Condition
25.5	16	7	5	5	N/A	6

Deck: Corrugation in good shape. Superstructure: Surface corrosion throughout with minor section loss at ends. Substructure: Concrete in good condition. Masonry with minor mortar loss in east abutment. Southwest masonry wing bulging. Toe-wall repair at west abutment not undermined. Channel: Stream is migrating westward, flowing into south corner of west abutment. Rocky bottom & vegetated banks. Fencing hanging on south side of bridge has minor drift accumulations.

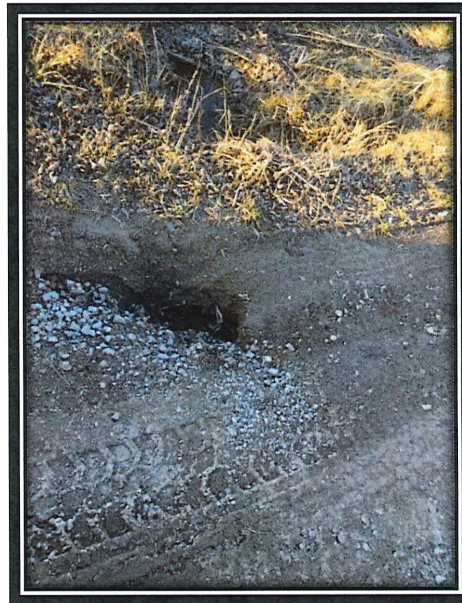
## Culvert #714: Pleasant Valley Road s/o 271<sup>st</sup> Street (CMP)

Structure Span	Structure Width	Deck Condition	Superstructure Condition	Substructure Condition	Culvert/Pipe Condition	Channel Condition
1.25	0	N/A	N/A	N/A	4	N/A

Hole in Road.

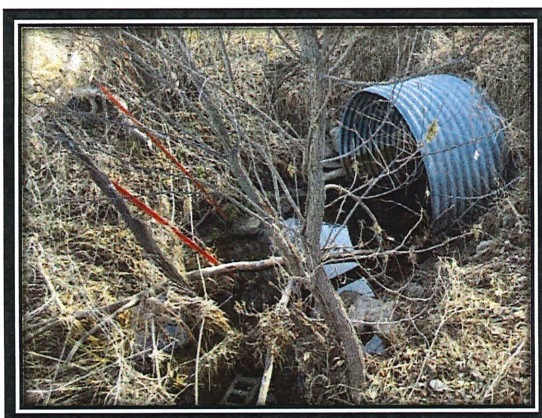
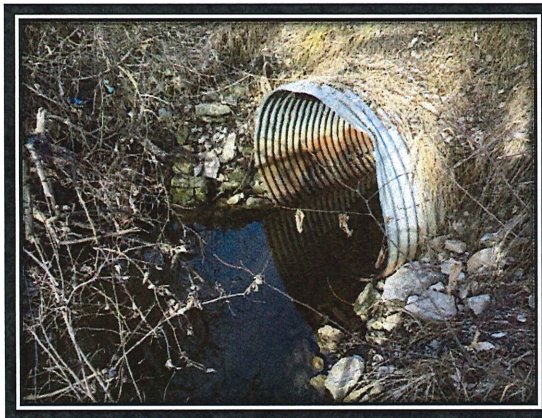
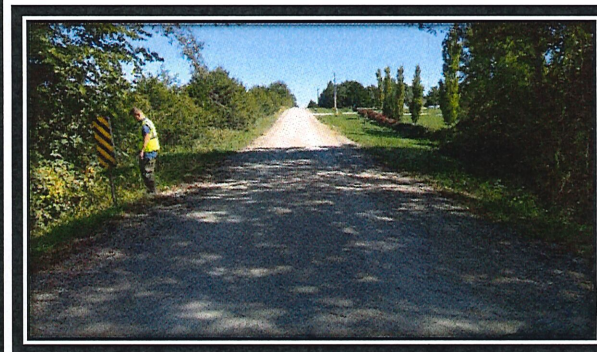
## Culvert #7: 215<sup>th</sup> Street e/o Sunflower (CMP)

Structure Span	Structure Width	Deck Condition	Superstructure Condition	Substructure Condition	Culvert/Pipe Condition	Channel Condition
6	40	N/A	N/A	N/A	4	6

54" X 72" Squash CMP. Haunches rusted out. Middle section bottom plate substantially peeled up. Partial infall channel restriction. Appears some structural integrity left; attention needed soon.

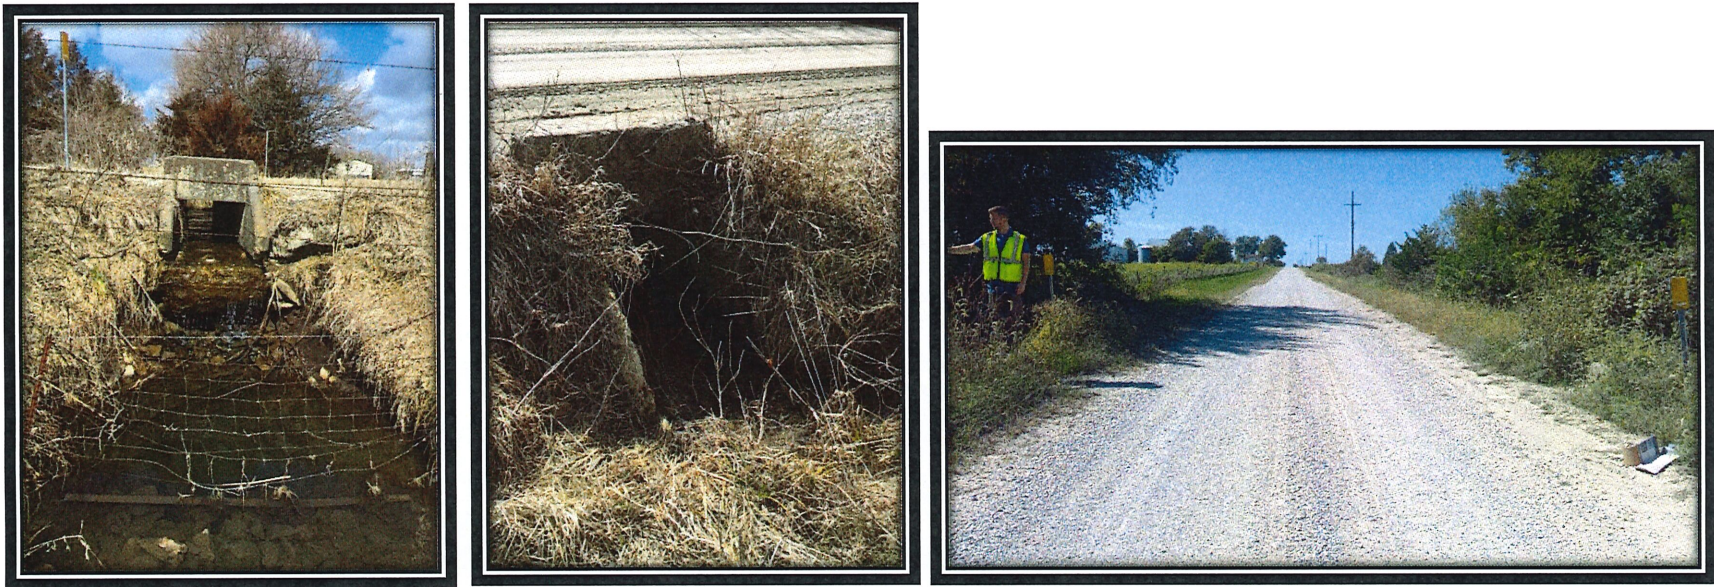
## Culvert #632: 263<sup>rd</sup> Street e/o Indianapolis (RCB)

Structure Span	Structure Width	Deck Condition	Superstructure Condition	Substructure Condition	Culvert/Pipe Condition	Channel Condition
3	24	N/A	N/A	N/A	4	4

With 4' apron-wingwalls. Outfall 3-4' drop to rubble riprap and pool. 2-3' back scour, apron-wingwall joint deterioration, end erosion. Infall minor restriction.

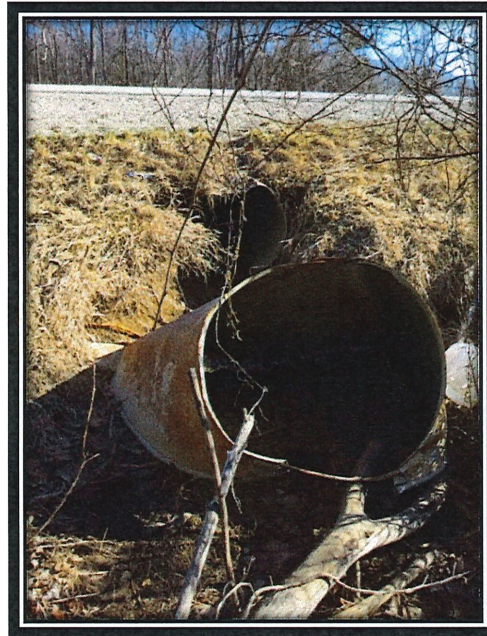
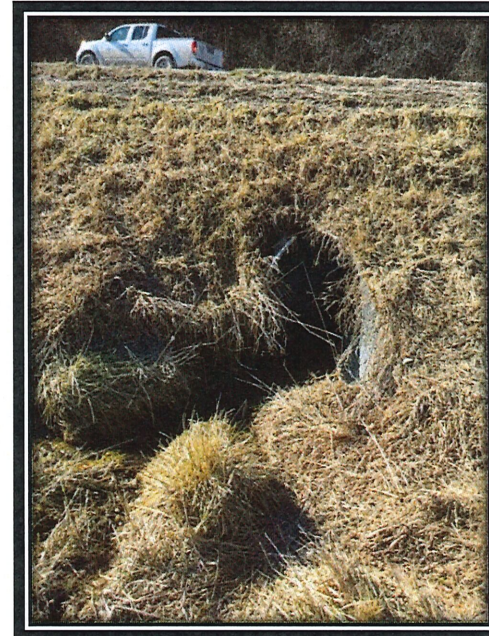
## Culvert #396: Harmony e/o Tontzville (CMP)

Structure Span	Structure Width	Deck Condition	Superstructure Condition	Substructure Condition	Culvert/Pipe Condition	Channel Condition
3	50	N/A	N/A	N/A	4	6

Outfall tube crown slight damage, end section completely displaced. Infall end section distorted and displaced.

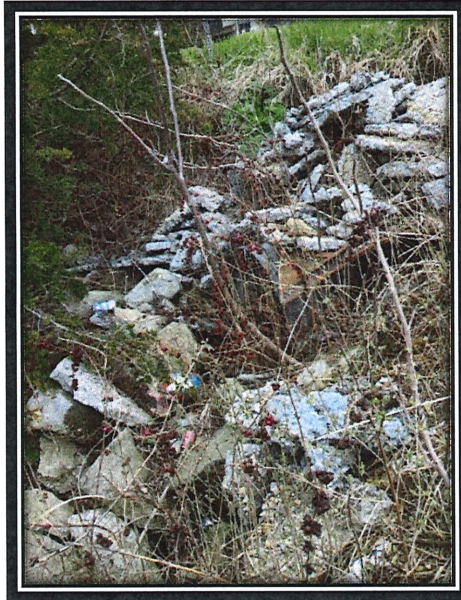
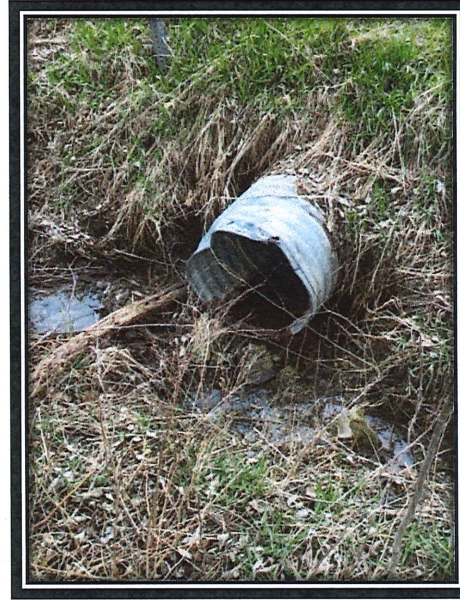
## Culvert #161: Quivira Road s/o 223<sup>rd</sup> Street (CMP)

Structure Span	Structure Width	Deck Condition	Superstructure Condition	Substructure Condition	Culvert/Pipe Condition	Channel Condition
2	28	N/A	N/A	N/A	4	6

Upstream pipe end sectioning showing considerable bottom of pipe deterioration.

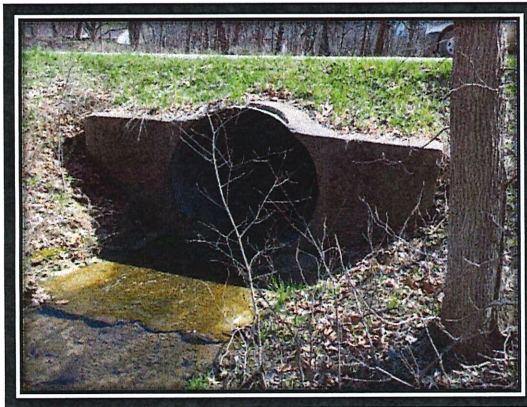
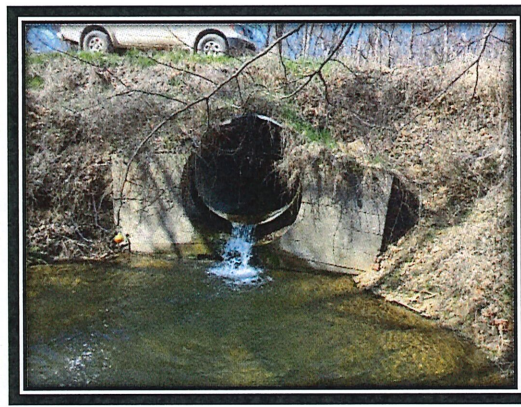
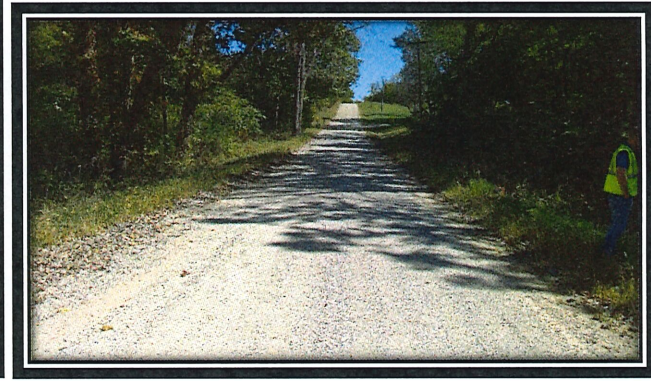
## Culvert #1362: 319<sup>th</sup> Street e/o Bethel Church (CMP)

Structure Span	Structure Width	Deck Condition	Superstructure Condition	Substructure Condition	Culvert/Pipe Condition	Channel Condition
6	46	N/A	N/A	N/a	4	6

W/HWs. Infall 6' concrete apron, deteriorating at cmp interface. Invert heavily corroded. Outfall 1' drop to concrete headwall bottom, back annular space 4'+.1' drop to rocky pool. Outfall HW broken/fallen away from cmp, side erosion cmp & HW progressing road.
